**CONTINUING ELIGIBILITY INSPECTION (CEI) REPORT**  
*FOR FLOOD CONTROL PROJECTS*

1. **Project Name:** Alenaio Flood Control Project
2. **Date of Inspection:** November 12, 2002
3. **Inspection Personnel:**

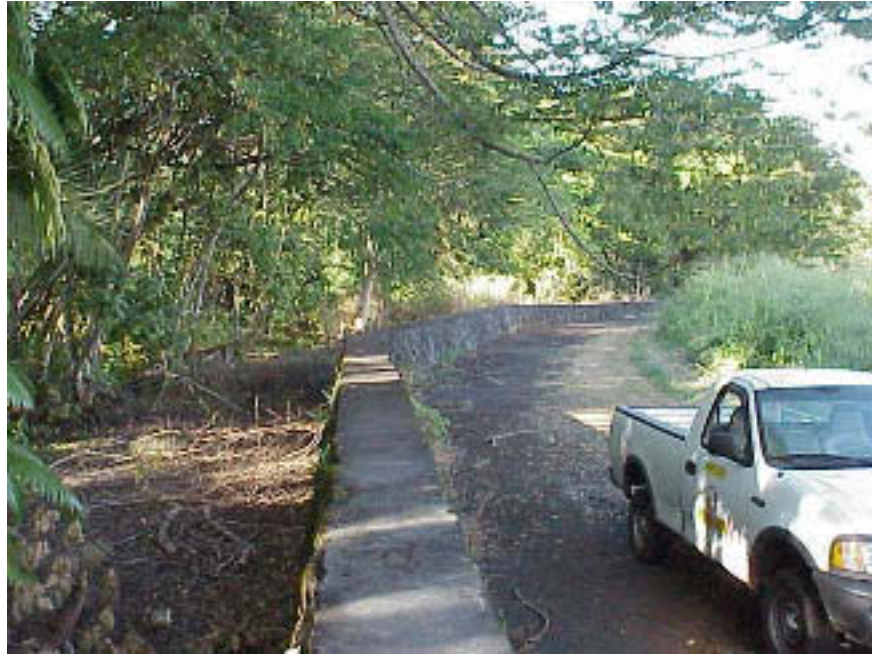
Floodwall "A"

a. Sta. 3+65, Floodwall "A", overview. (Sta. 3+65 CRM wall begins upstream - Sta. 0+00 wall ends downstream).

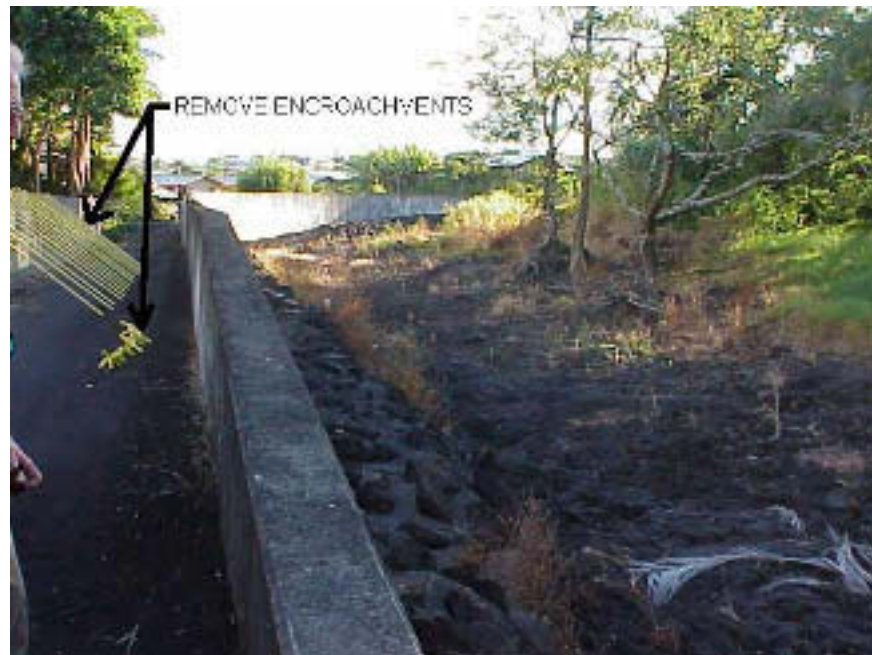
Floodwall "B"

b. Sta. 4+66, Remove yellow pole and bracket encroachments from blocking maintenance road entrance to Floodwall "B", Right Bank (RB). Remove vegetation from Left Bank (LB) graded area (®). (Sta. 4+66 wall begins upstream end - Sta. 0+00 wall ends downstream).

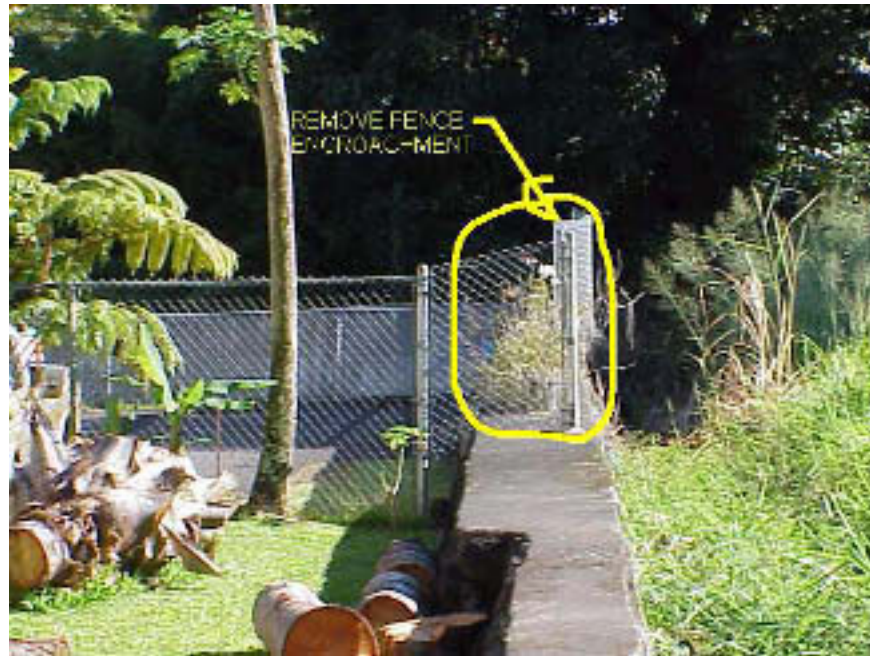
Floodwall "C"

c. Sta. 1+80, Remove fence encroachment on top of Floodwall "C". (Sta. 0+00 wall begins in parking lot, Sta. 2+00 is elbow, Sta. 3+36 wall ends downstream).

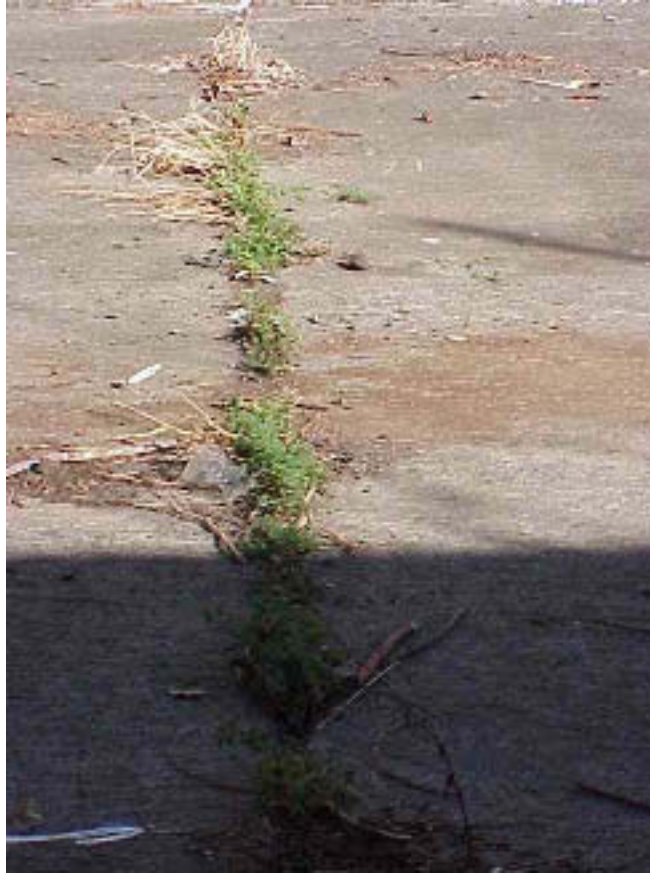
d. Sta. 23+00, remove vegetation from construction joint invert of concrete channel. Note: damaged joint will be repaired under (CORPS) page ring 4, item #3.

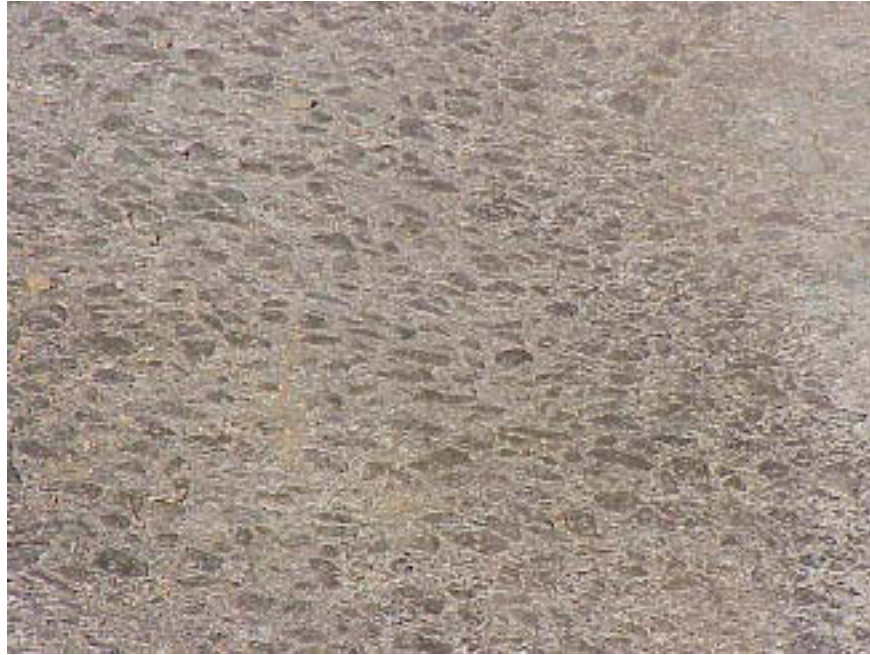
e. Sta. 17+00, right bank concrete channel invert between the end of splitter and Kinoole Street Bridge, monitor exposed aggregate resulting from high water and debris velocity scouring.
